INTRODUCTION

ENVIRONMENTAL AND SERVICE CONDITIONS

STORAGE

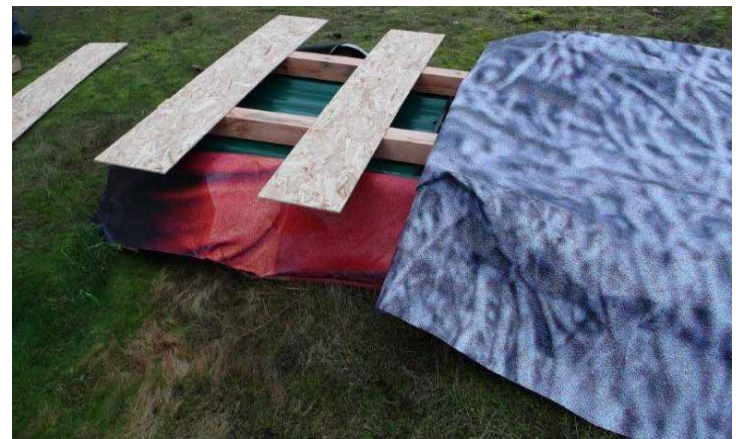
Example of proper storage
